## FIGURE: Exhibit A-1 USGS Map

**QC LABORATORY**  
835 WEST AVENUE  
PORT READING,  
MIDDLESEX COUNTY, NEW JERSEY

## BOUNDARY SURVEY TAX LOTS 1.01 & 1.02

## **EXHIBIT B**

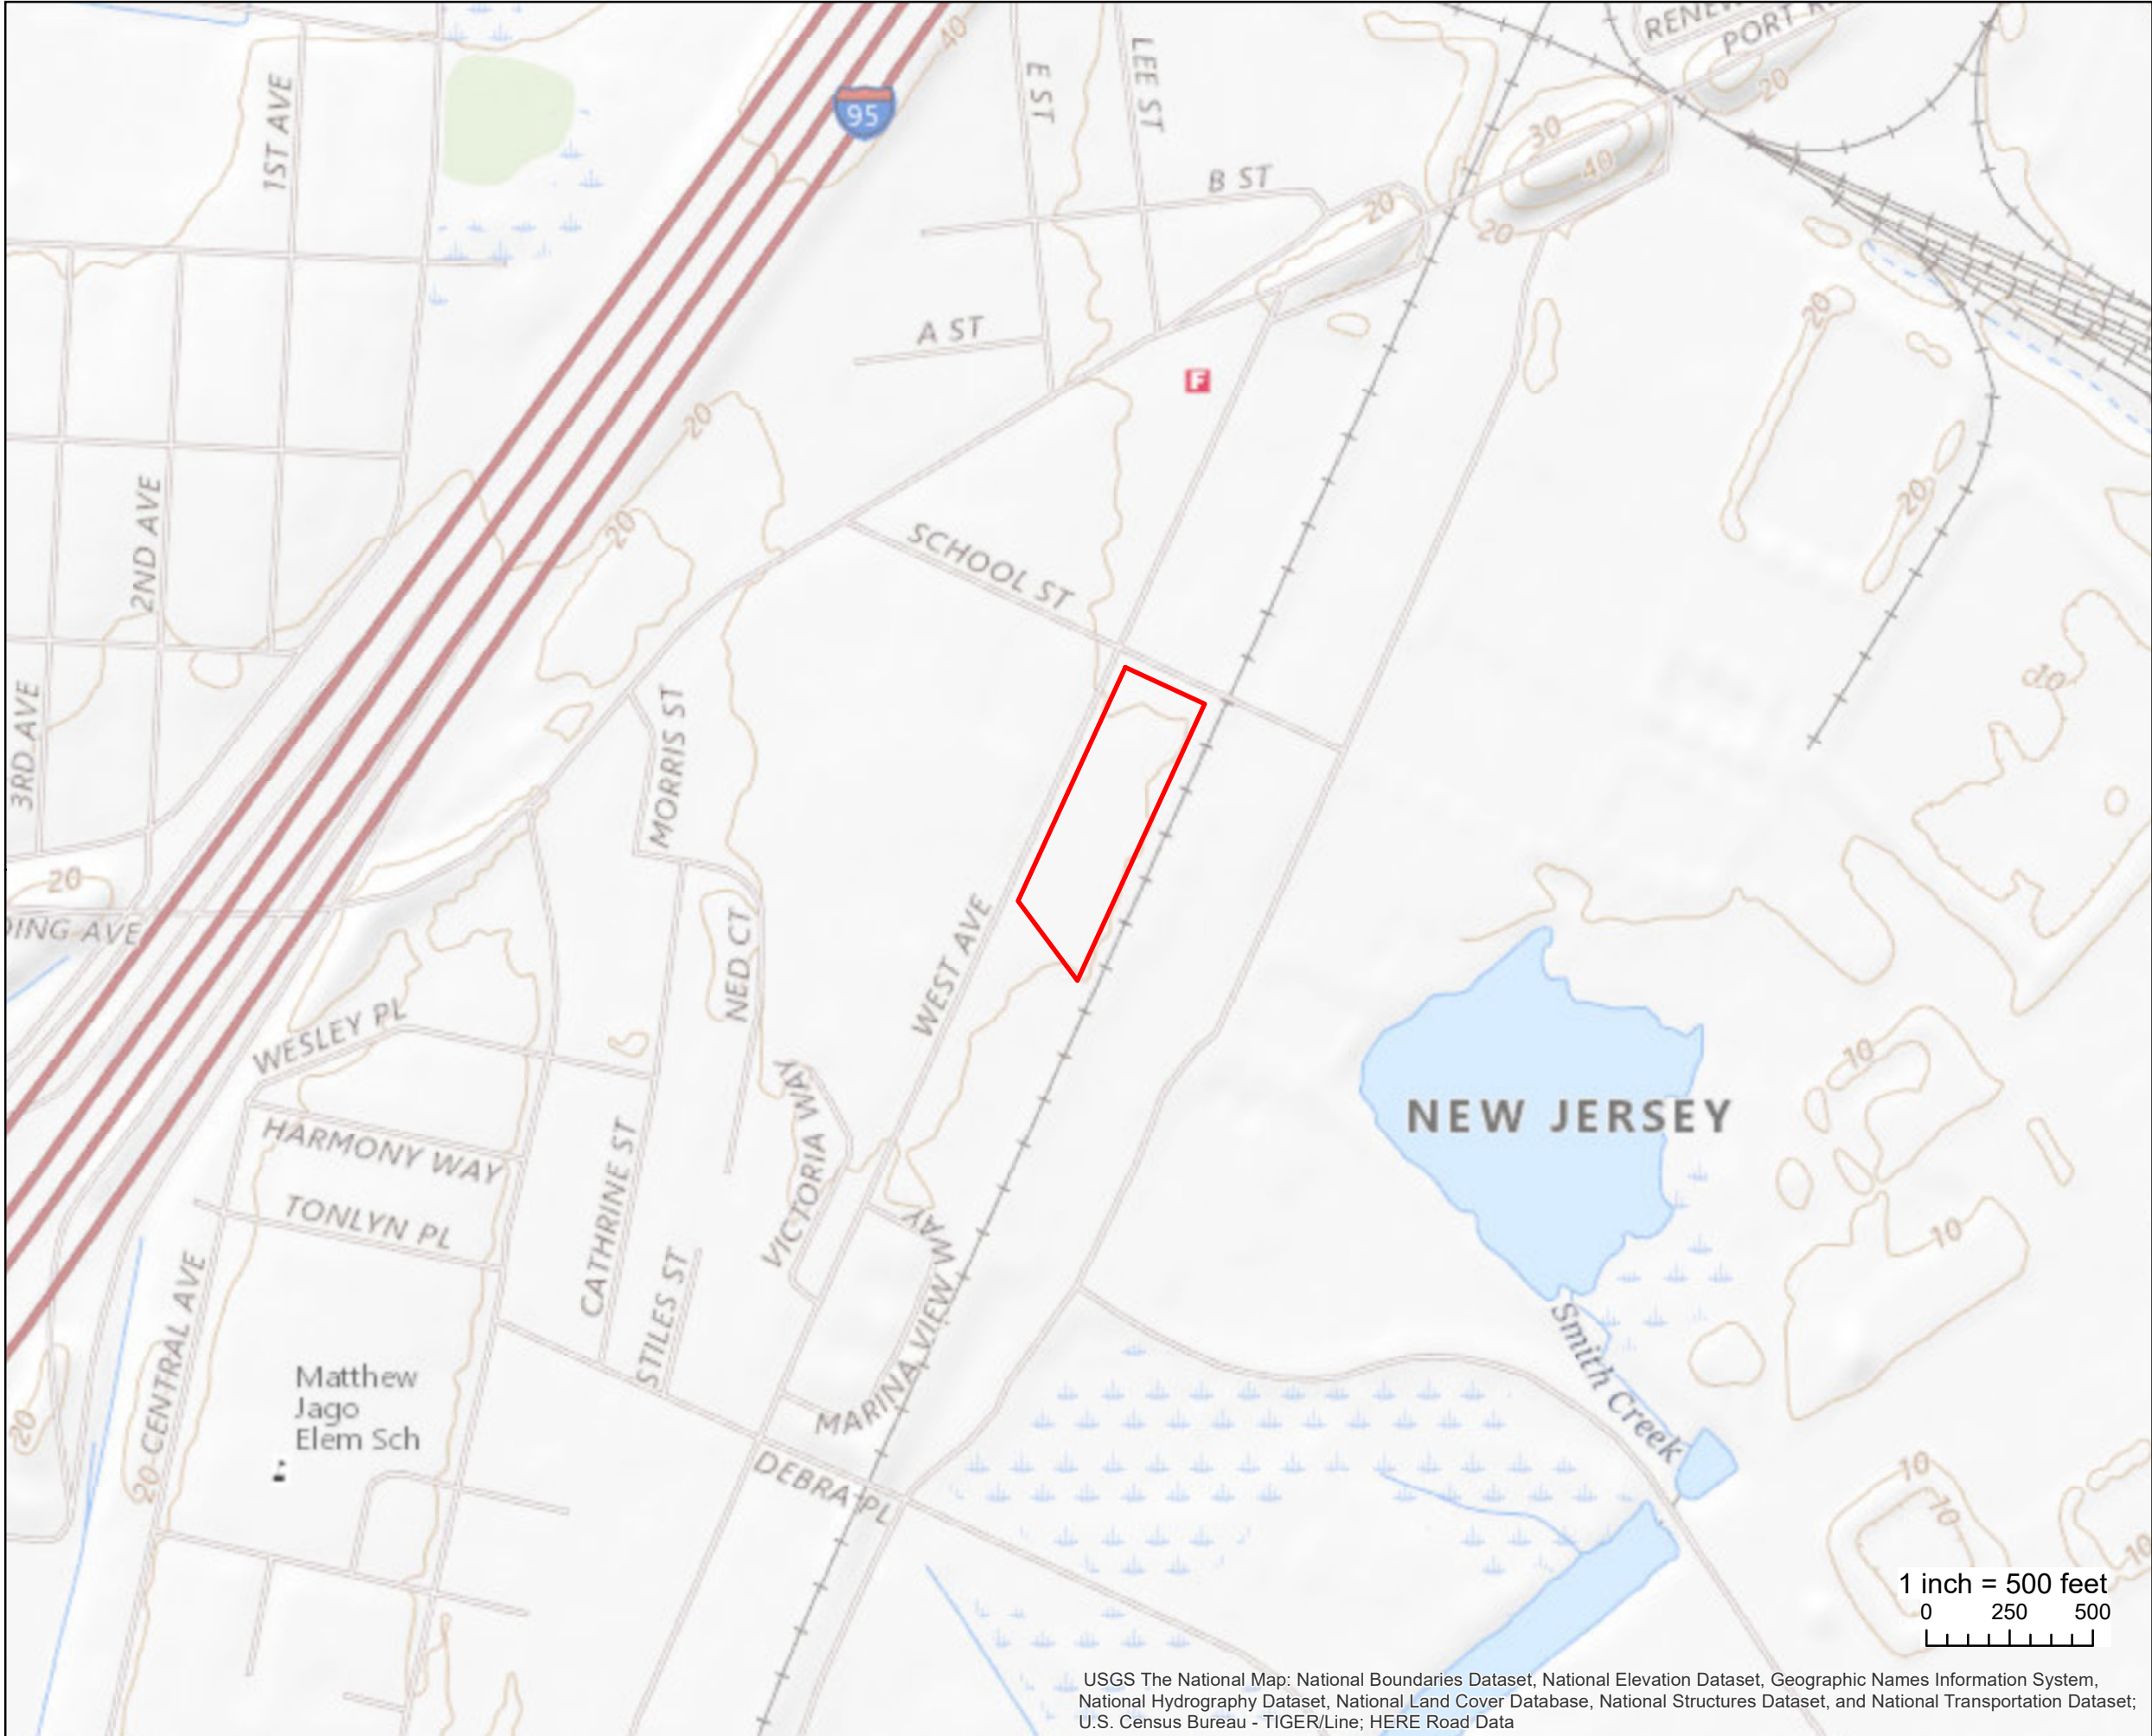
1. Street adjacent to the northern border of the site is incorrectly labeled in the underlying USGS National Map as "SCHOOL ST." The correct street designation according to local tax maps is "MILOS WAY."
